The Church of the Holy Cross Binsted, Hampshire

Quinquennial Inspection Report 2023

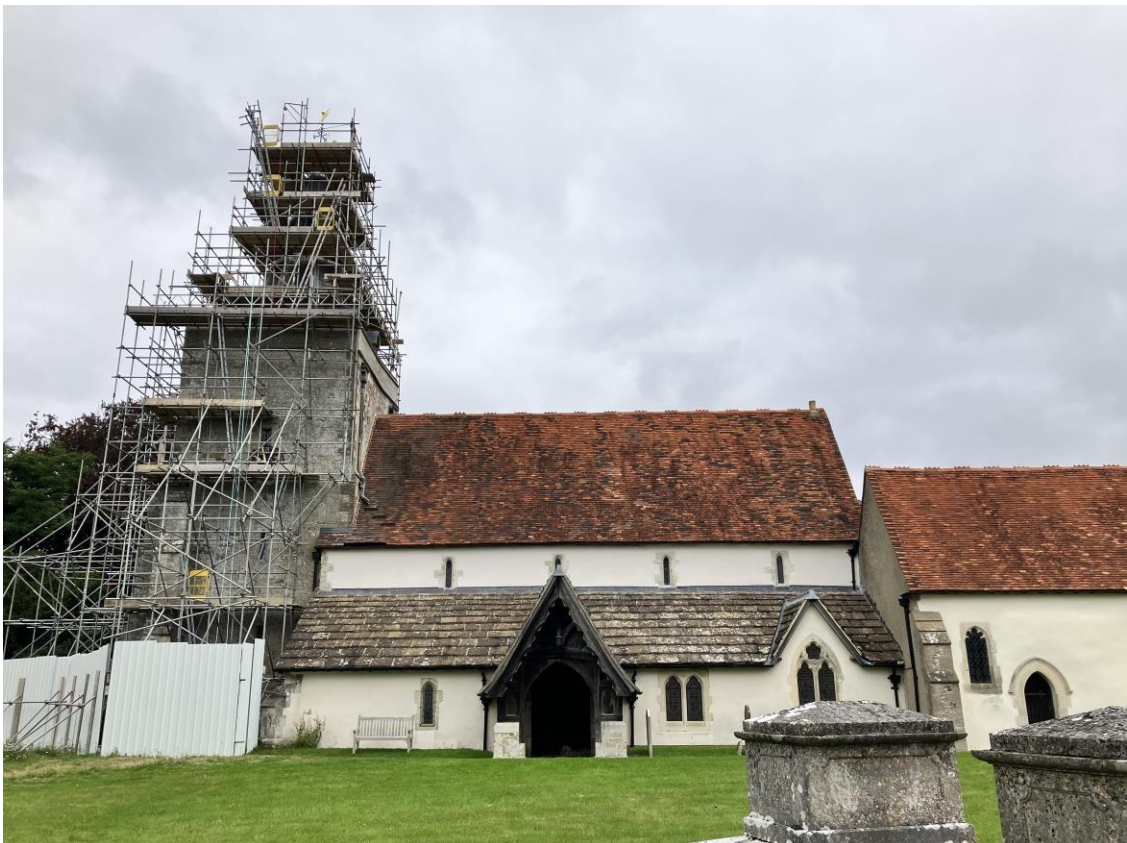
above: The church building seen from the south, August 2023, nearing the end of the post-storm damage works

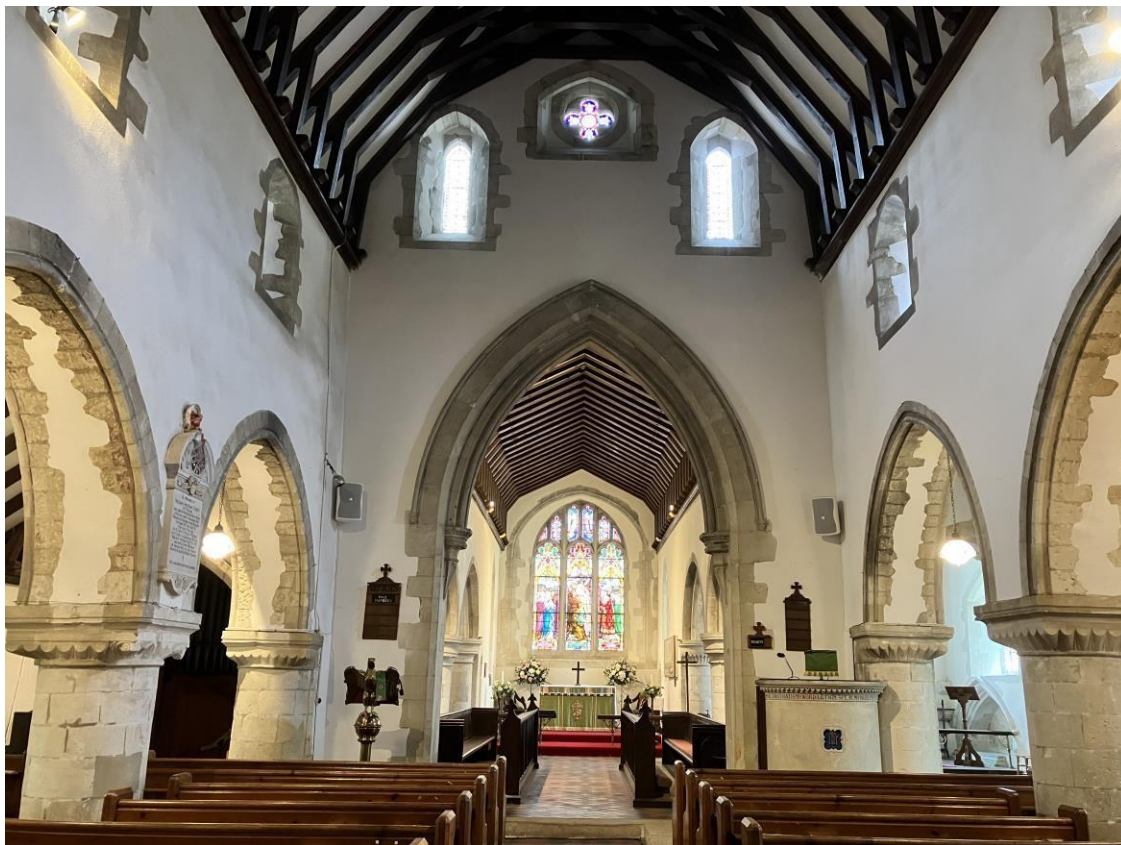
above: The interior looking eastwards, with Capronnier's window at the eastern end of the chancel.

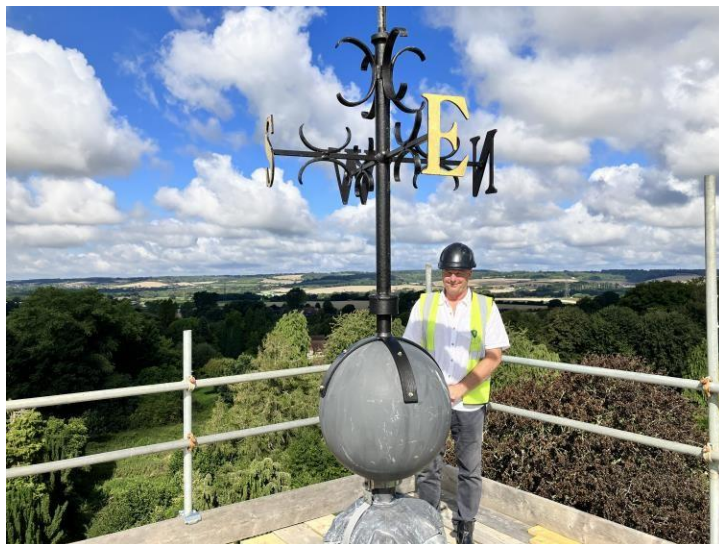
above: The new spire apex sphere and lower part of the weather-vane, with contractor Conal Kennedy of Imperial Construction.

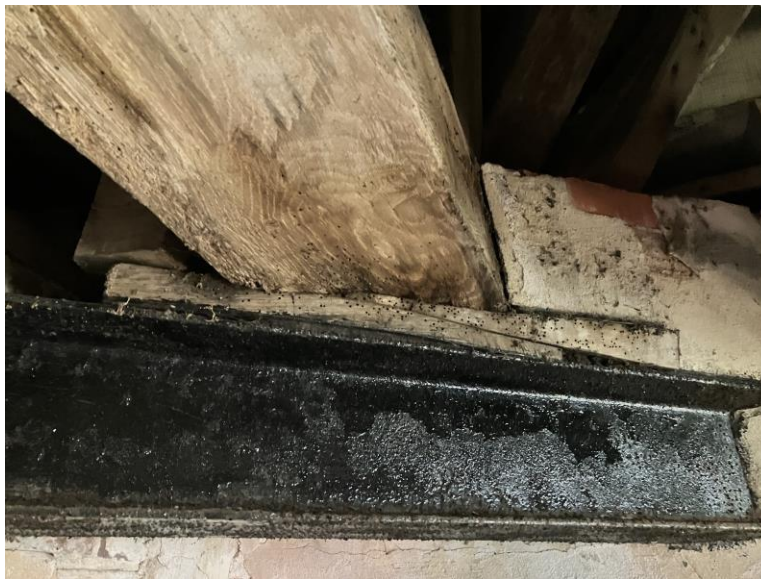
above: Evidence of beetle activity, south-western corner.

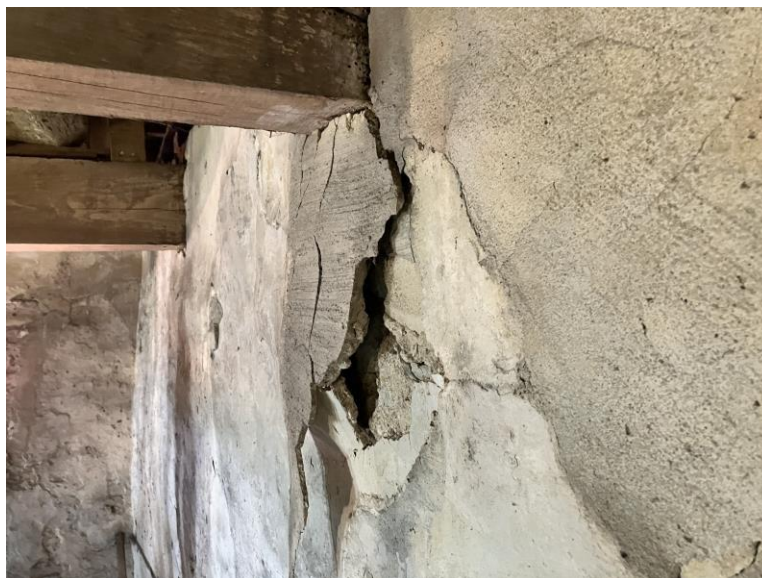
above: Loose plaster in belfry

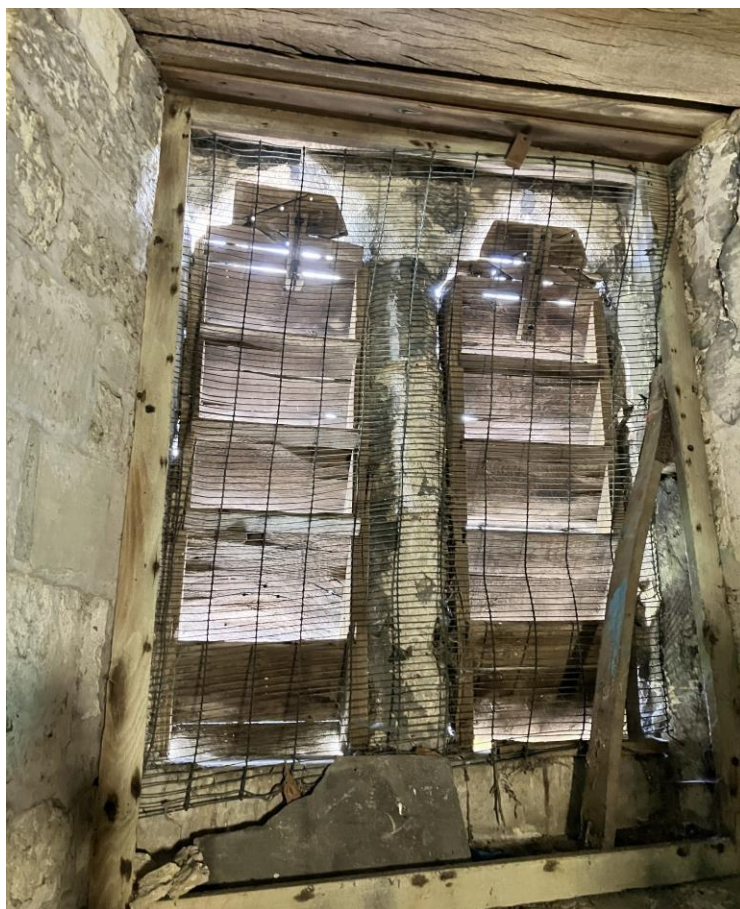
above: Decaying louvres, eastern side of belfry

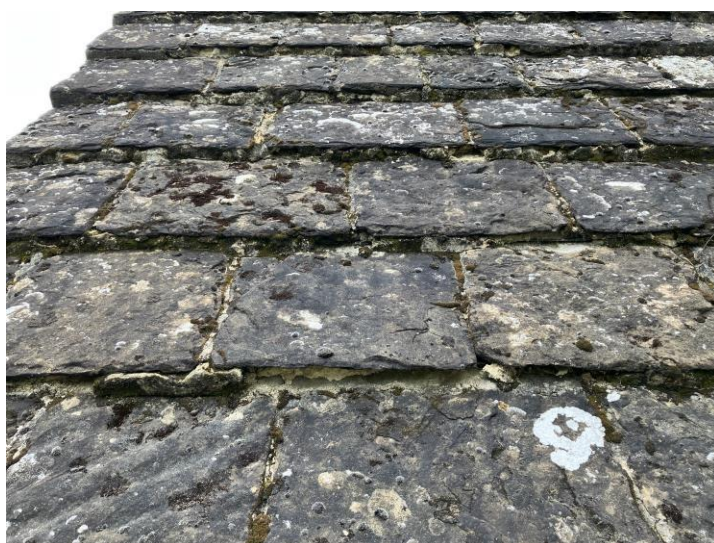
above: Defective pointing between Horsham stone slates on south aisle roof.

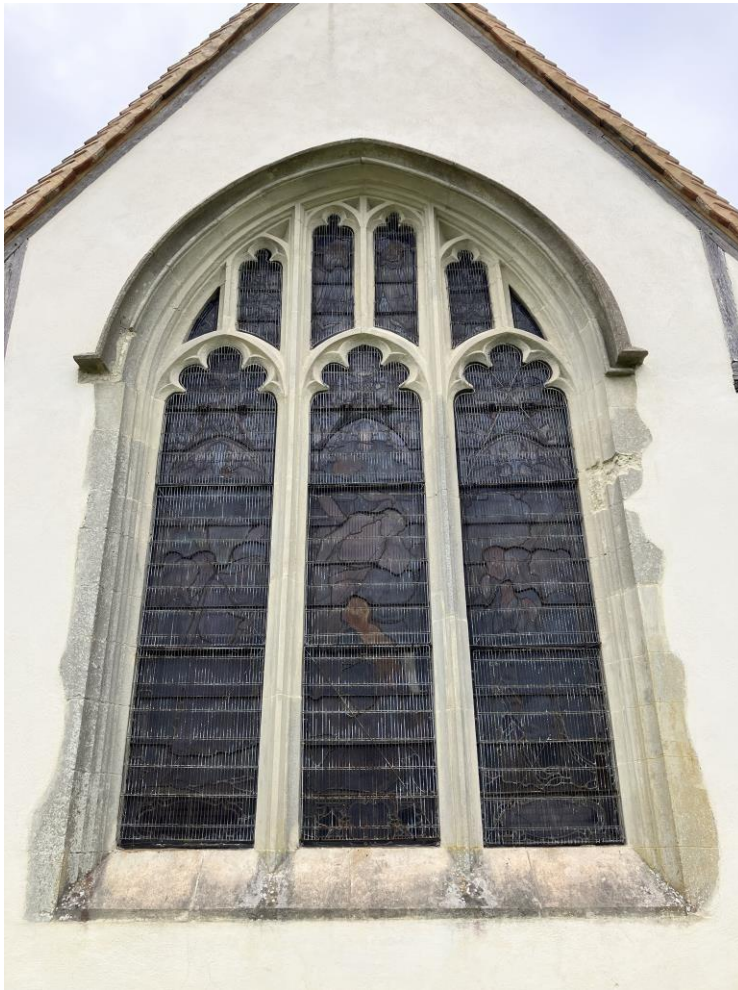
above: The Chancel east window. Note uniform-looking masonry, which is, in fact, cement-based repair material.

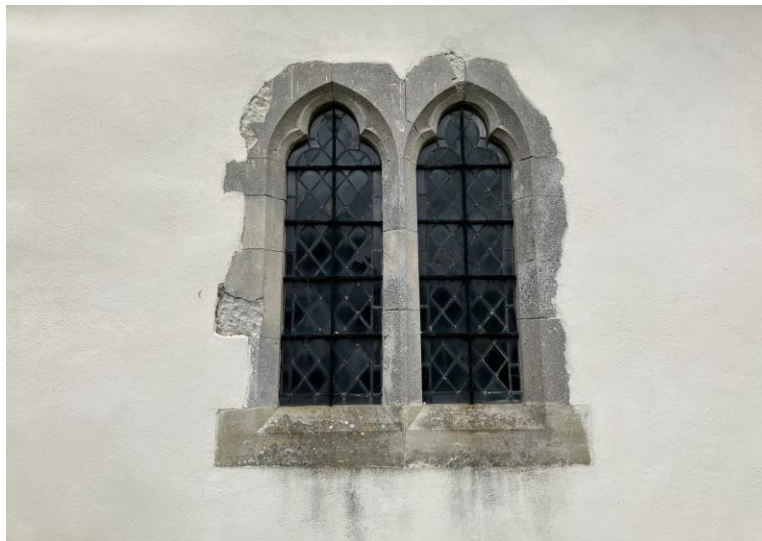
above: Lady Chapel, south side, eastern-most window

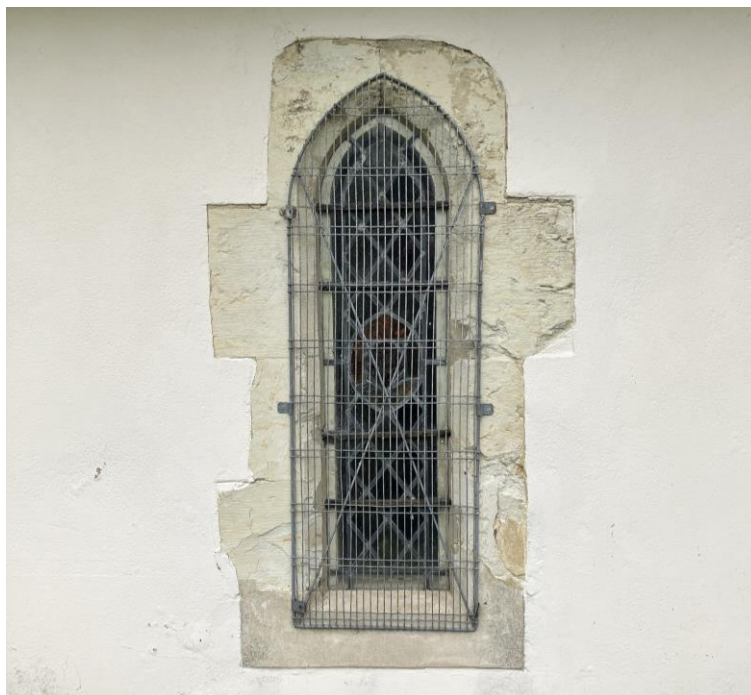
above: South aisle, window west of porch. Note very poor condition of masonry window dressings.

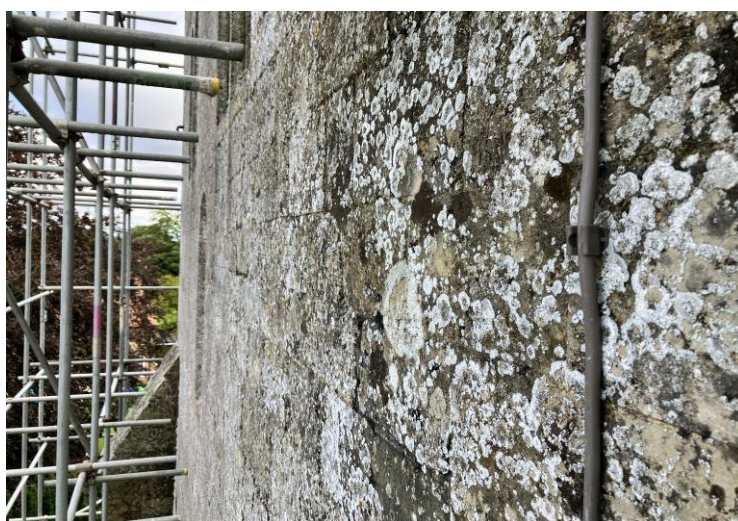
above: West face of tower, seen from scaffolding.

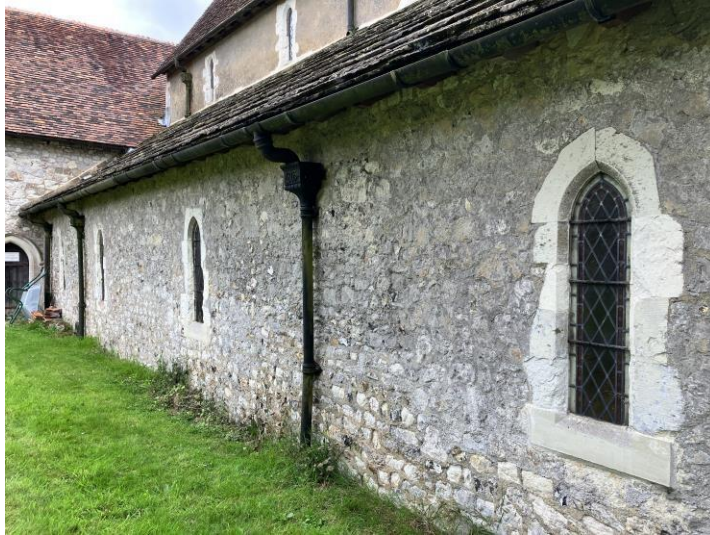
above: The north aisle at low level.

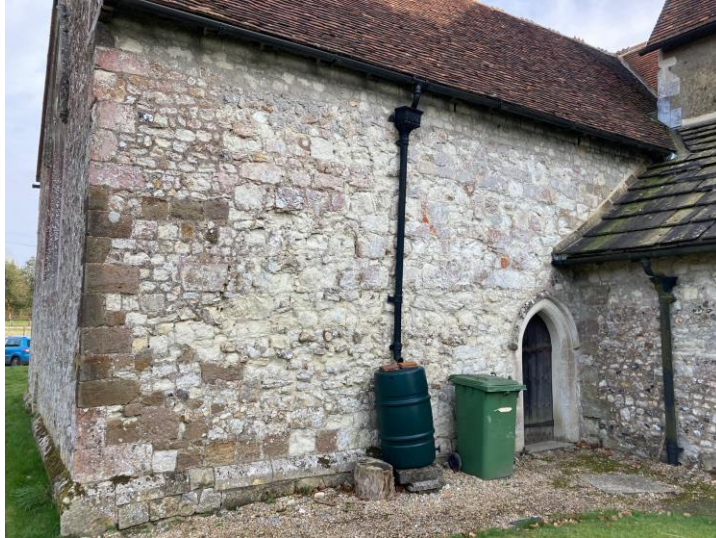
above: Westcote chapel, western elevation.

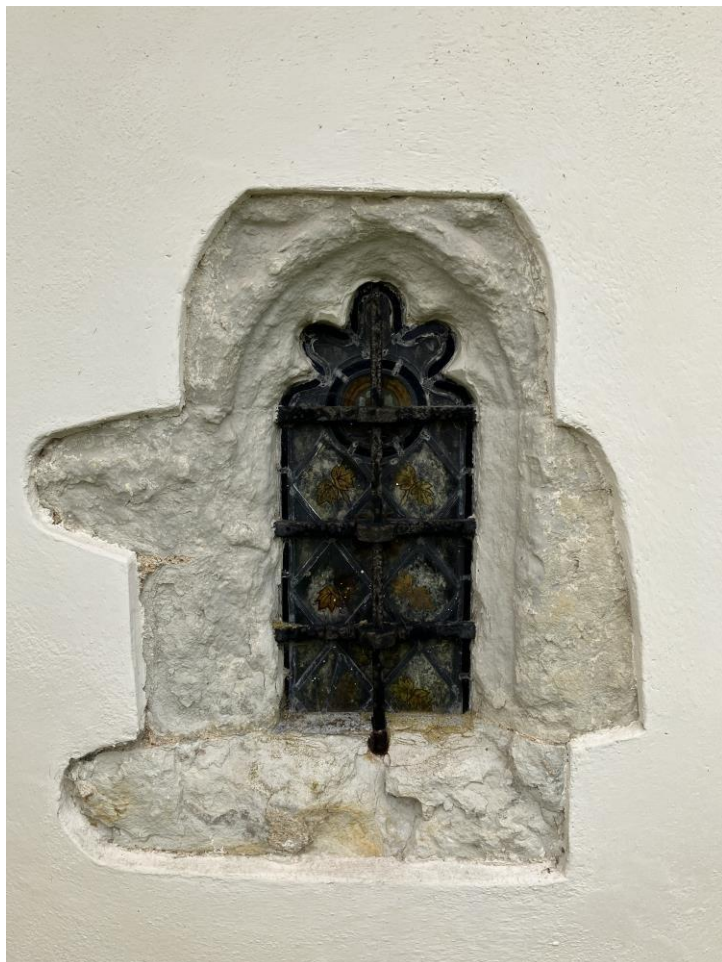
above: Vestry east window, external condition

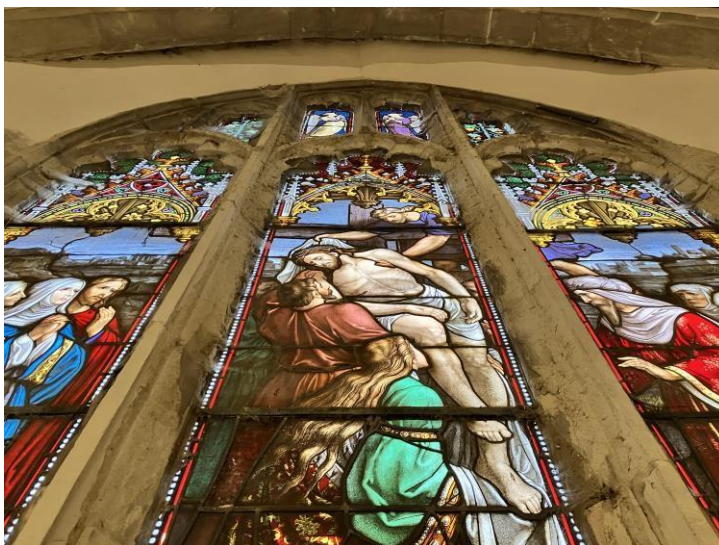
above: The chancel east window; detail view of central light.
